1953 Morris Minor Van at start of Covid-19 Lockdown

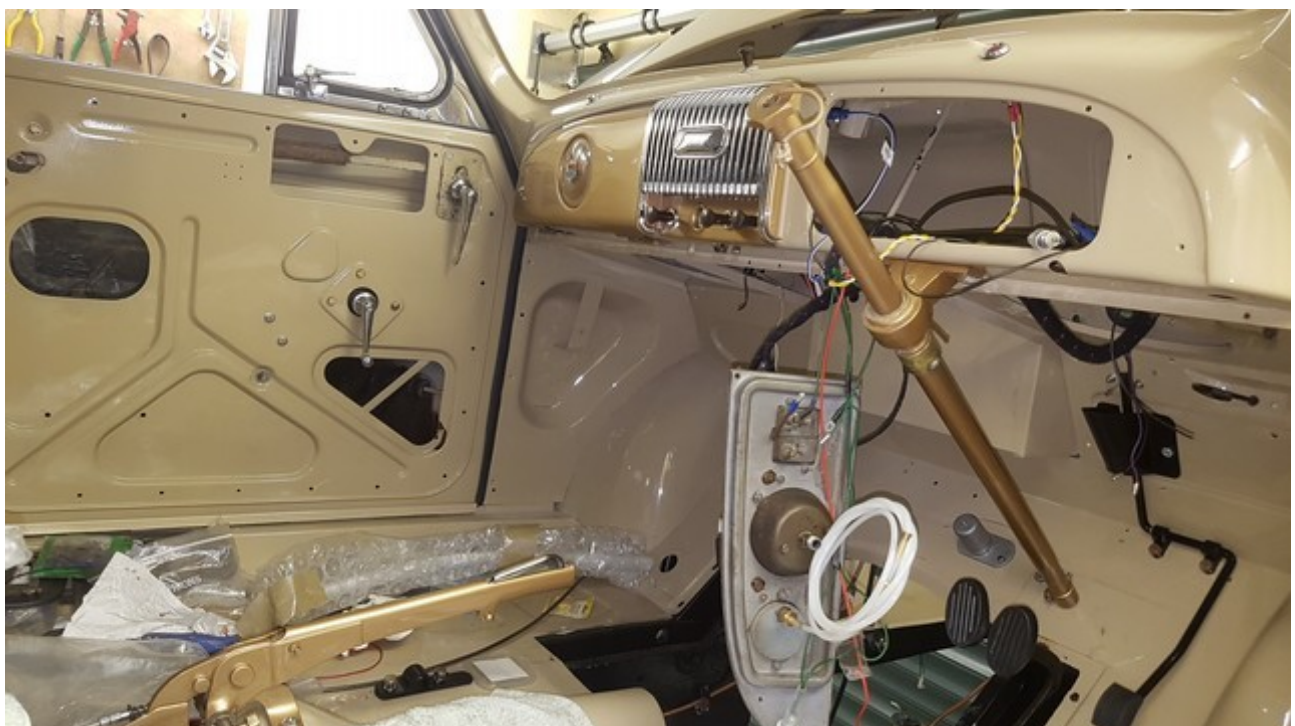
**Work begins – Dashboard starts to go in
Handbrake now fitted
Steering column fitted**

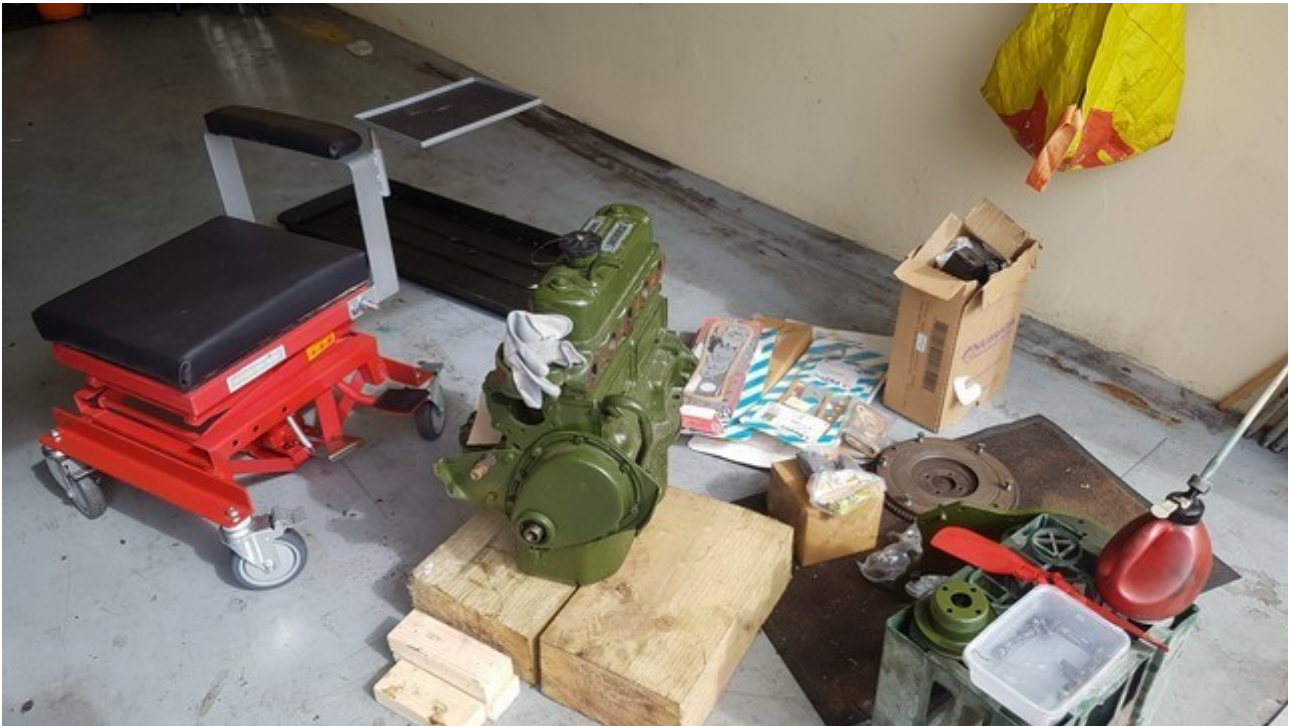
Engine requires pulley, water pump, oil filter, dynamo, starter motor, flywheel, clutch etc.

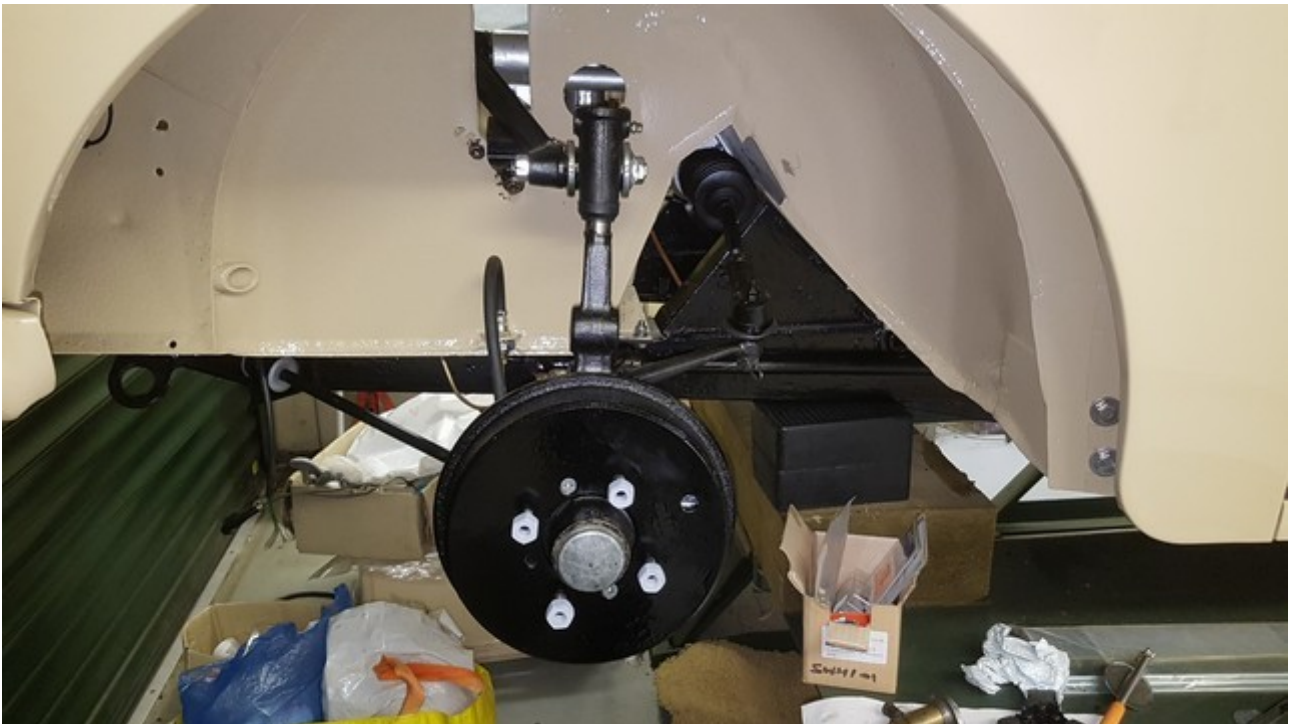
Brakes & suspension are overhauled and rebuilt

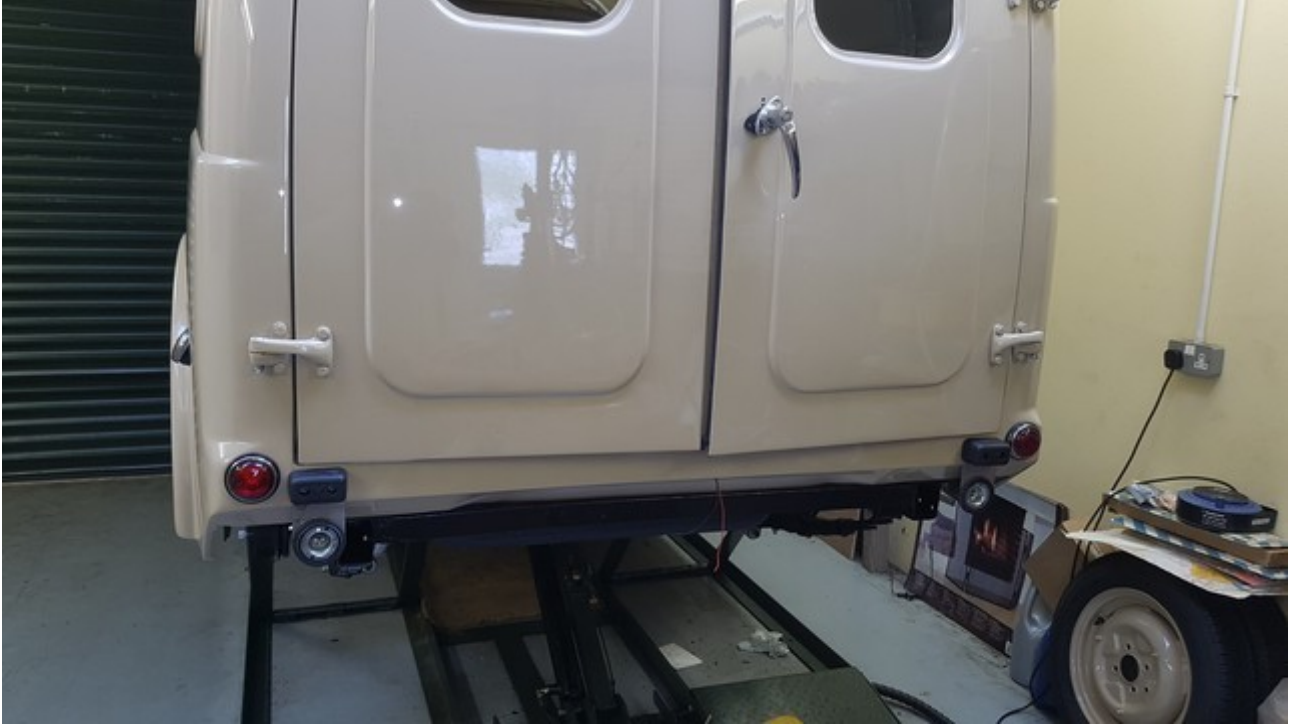
All rear lights are converted to LED
Rear flashers are installed below bump stops

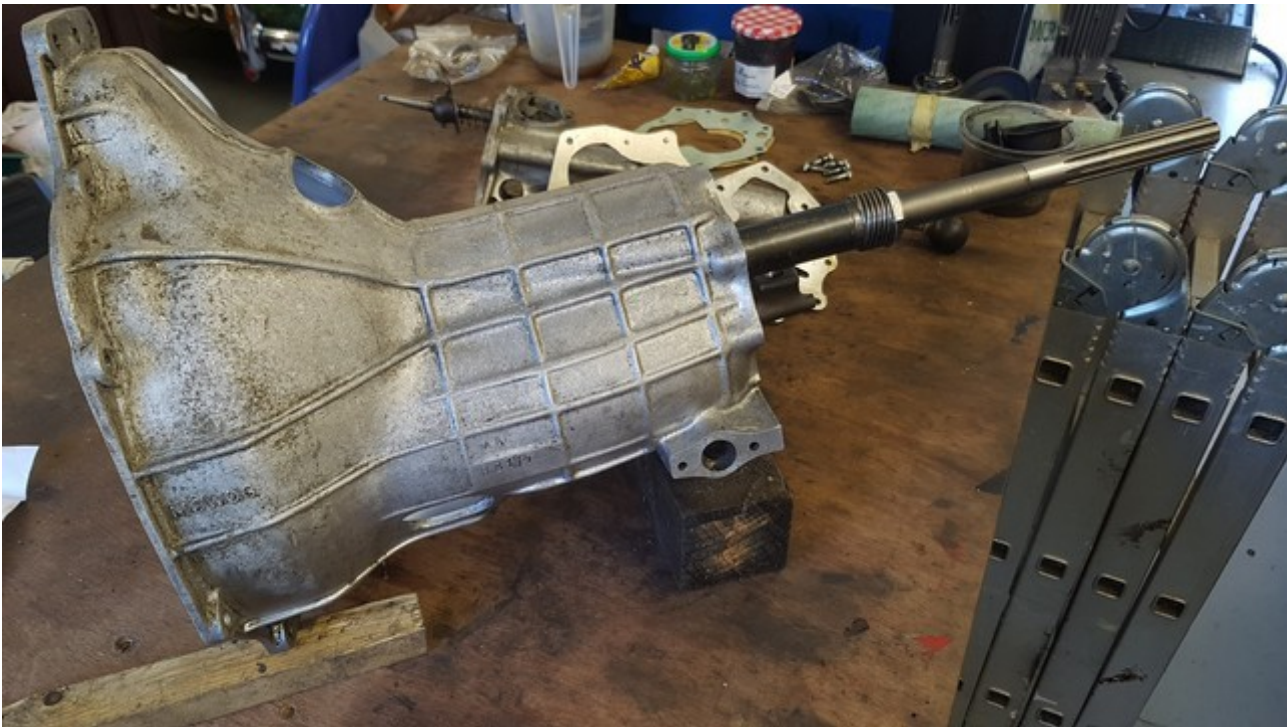
New Syncros, Bearings and first gear - I rebuild the gearbox with care.

I rebuilt the gearbox with new bearings, syncro cones etc.
The front half is a later design but I kept the long gearstick by making a 5mm adaptor plate and re-engineering the reverse gear gate.

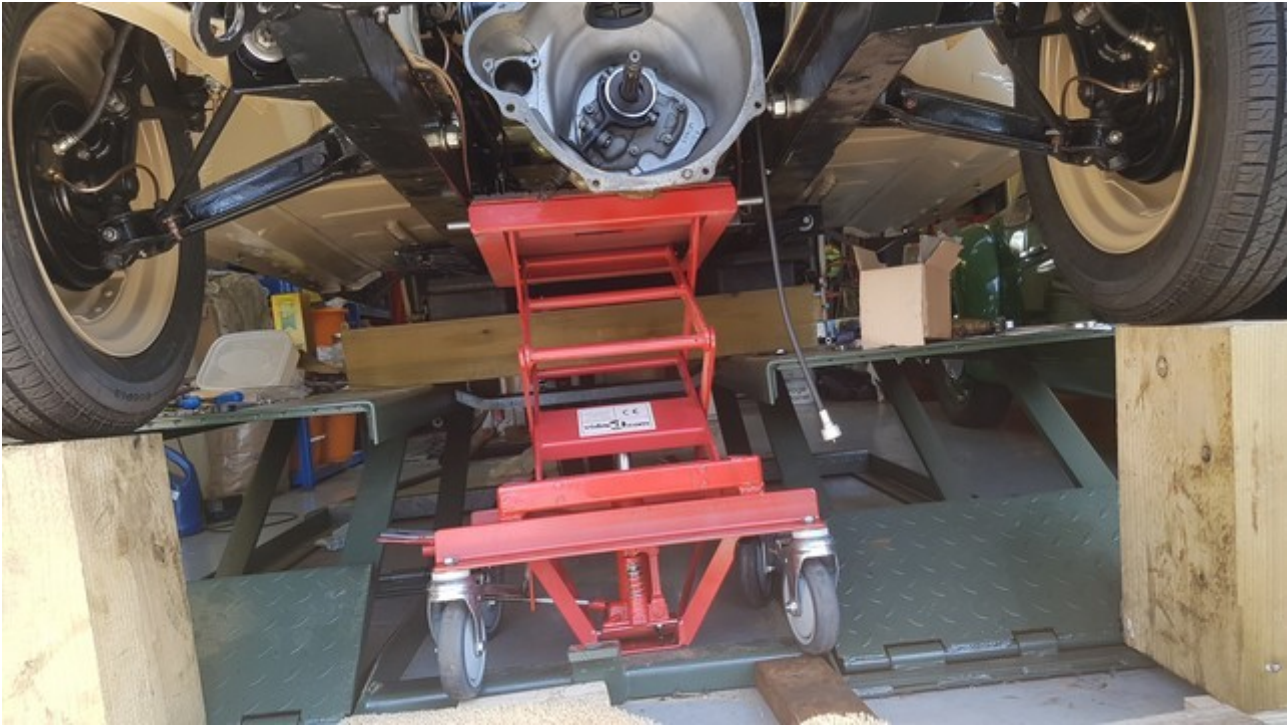
Gearbox installed using my hydraulic seat as a jack

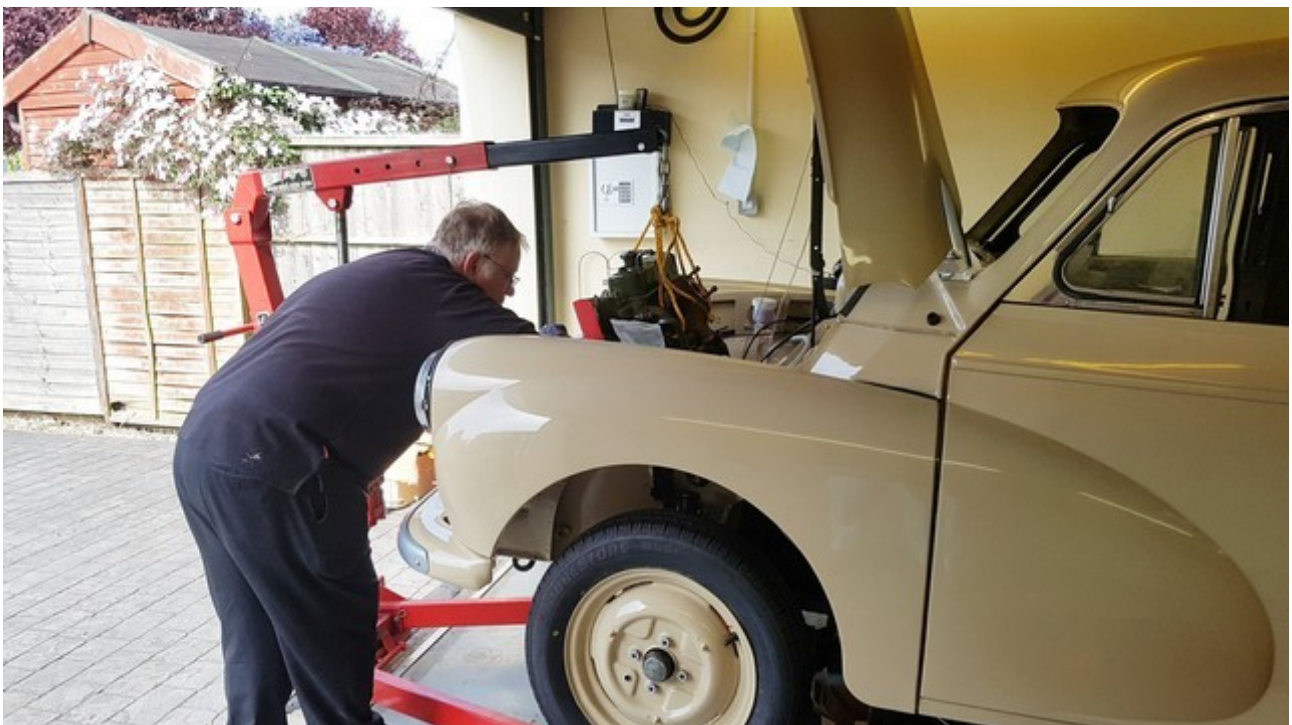
The engine has to be put in sideways then rotated to fit onto gearbox.
Social distancing prevents me getting an extra pair of hands.

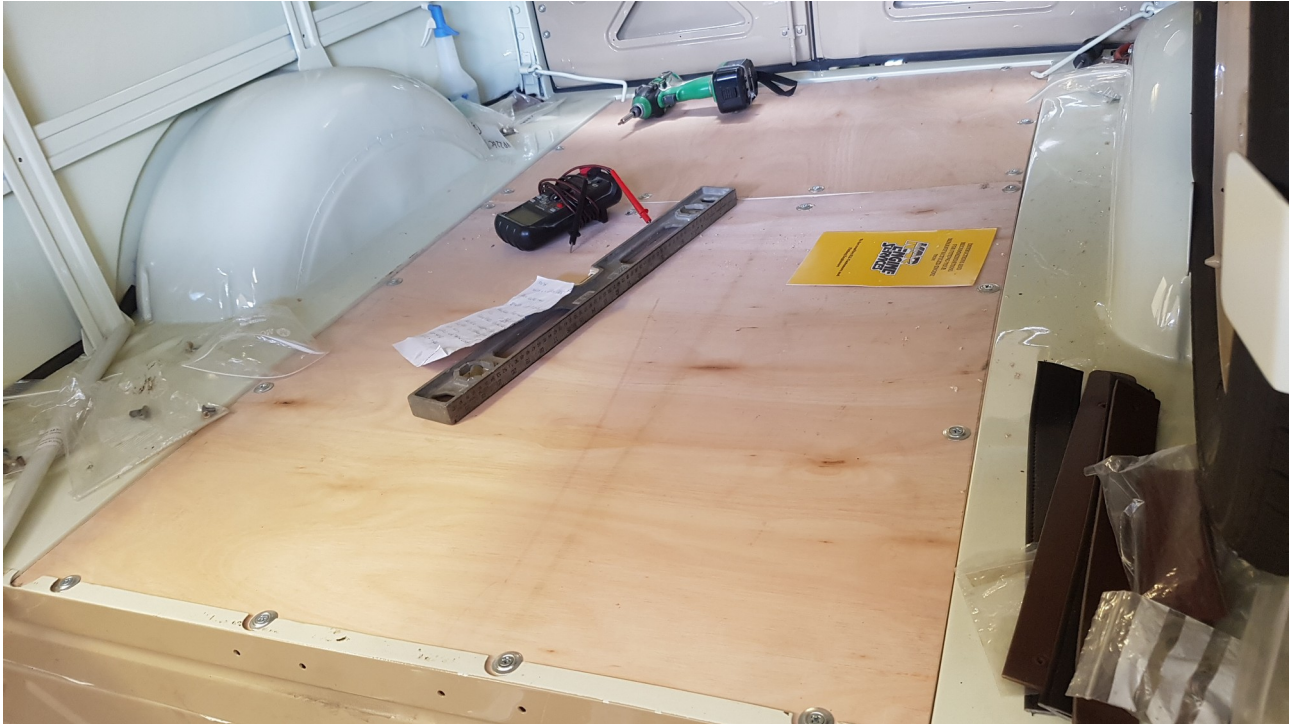
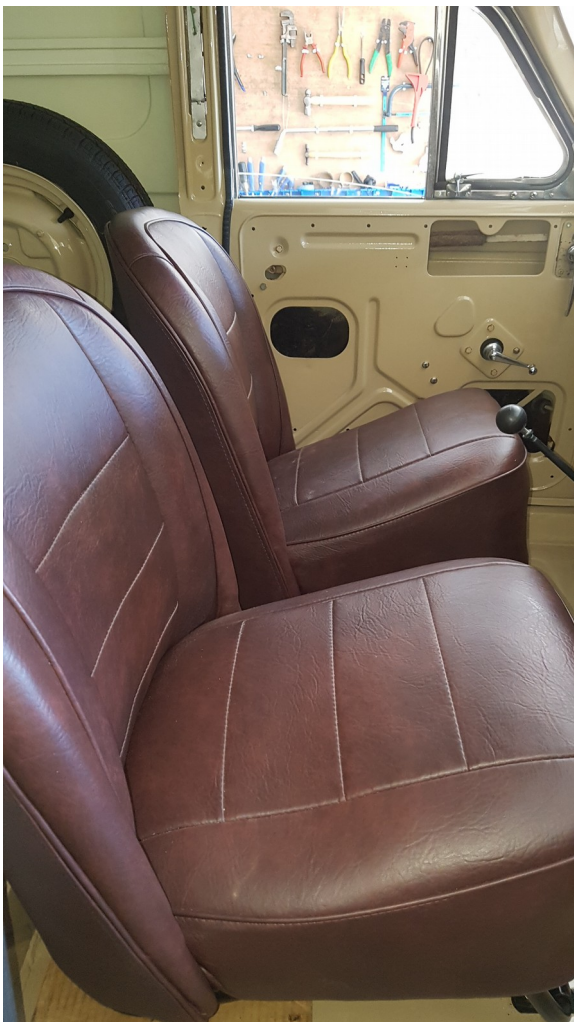
Cargo Floor made of plywood with support frame

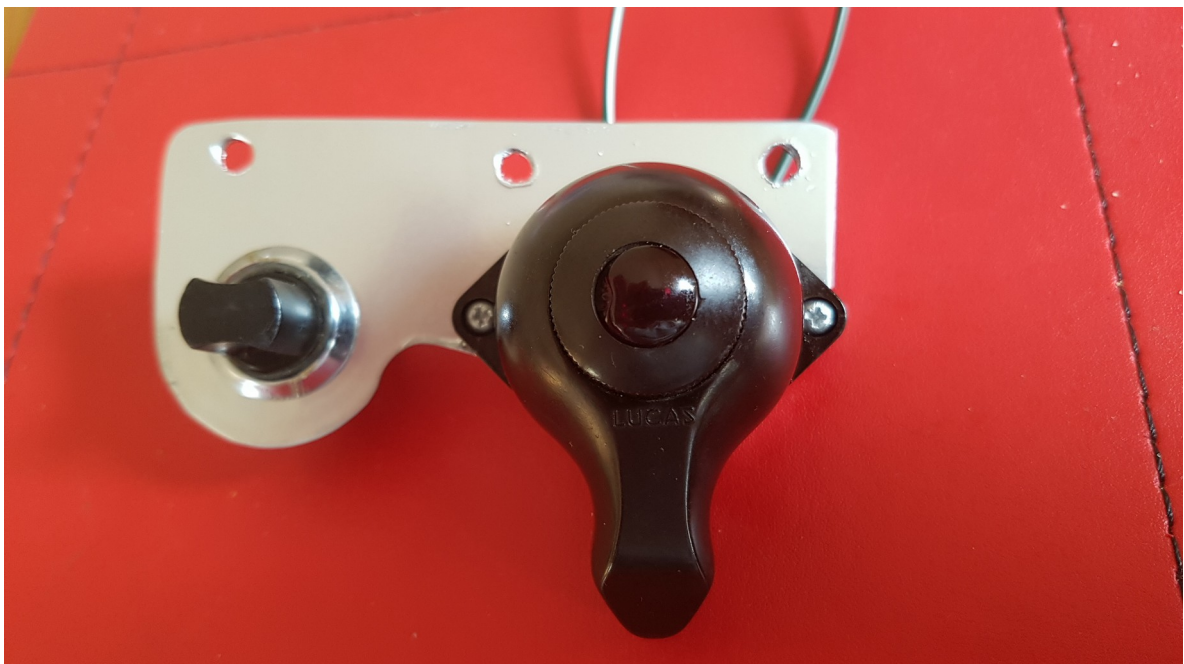
The Bakelite indicator Switch(es)

The small switch to the left disables Trafficators whilst the large switch operates flashers and Trafficators if enabled. The centre red lens has since been replaced with a green lens which I made on my lathe.

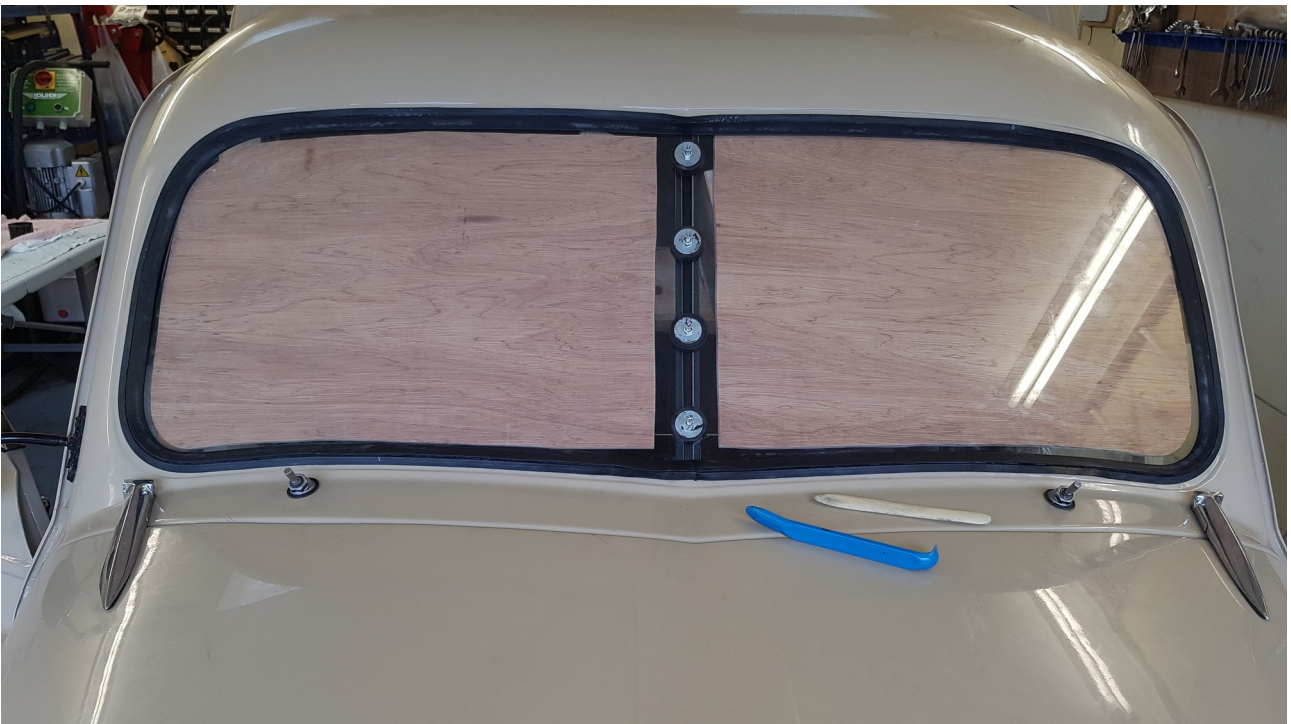
Preparing to fit windscreens (Cross beam braced in doorways.

The screens are in place with centre bar next to fit.
(Note : Plywood sheets made to spread the load as wedges used to push screens in)
